Special Report 77-14

RUNWAY SITE SURVEY

Pensacola Mountains, Antarctica

June 1977

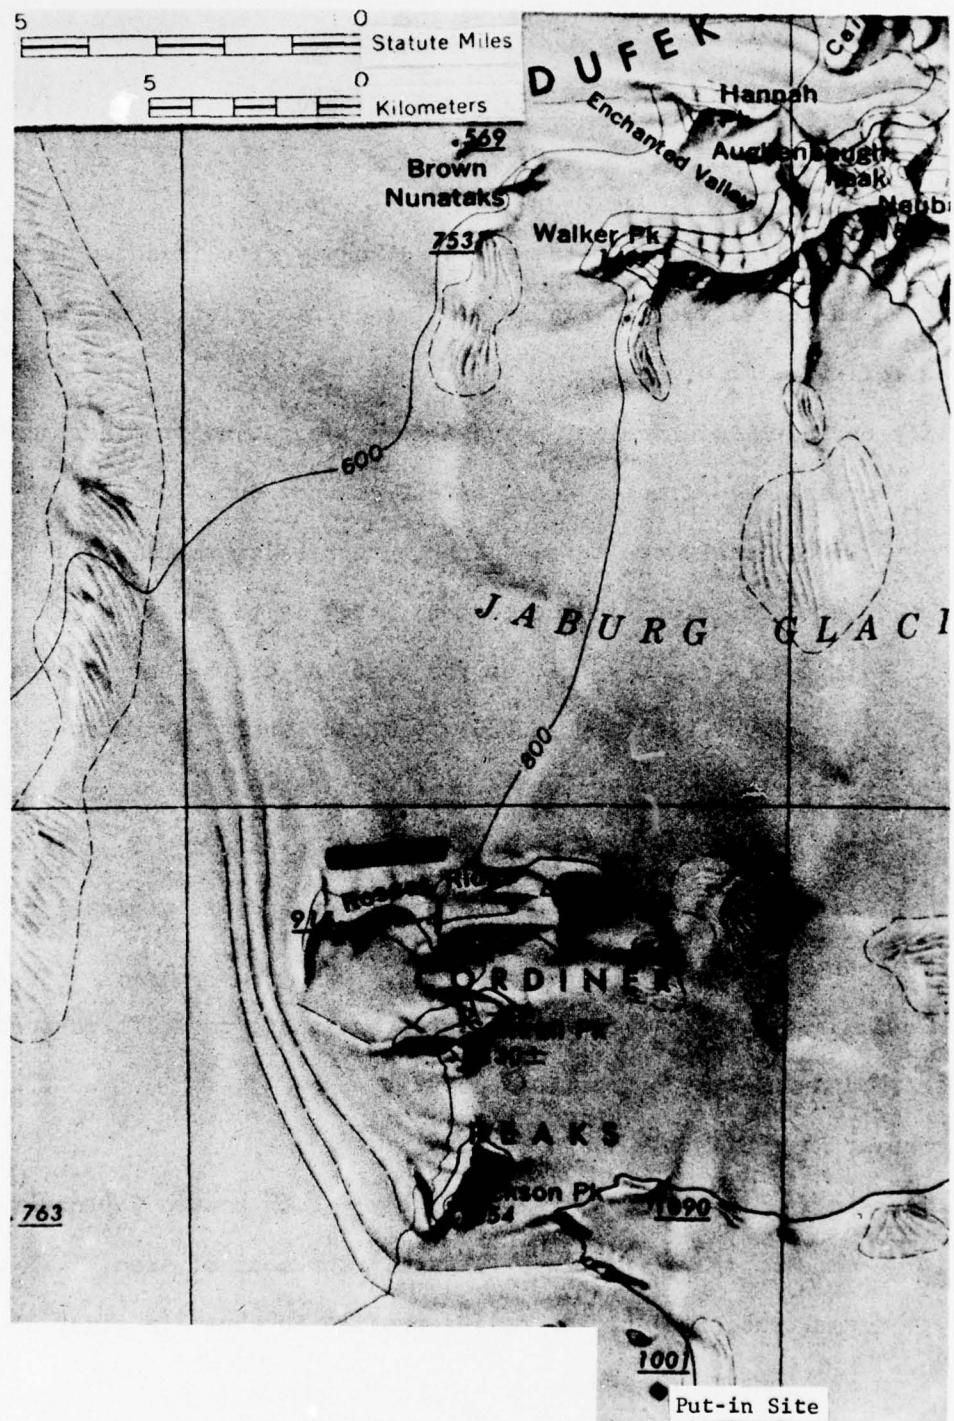
Ice Surface: microrelief up to a few cm high, no prominent cracks, relatively free of snow, extent of snow dunes or patches (up to 15 cm. high) can be seen in Figure 5 (a snowmobile trail at left, footsteps in the center), view is to the east; Figure 6 is a view to the west; at the east end of the survey area the surface is slightly rougher ("cupped" surface) and free of snow (Fig. 7). Some crevasses appear at the surface some 500 m beyond the east end of runway survey area (Fig. 8). These crevasses run in a NE to SW direction and are generally less than 1 m wide.

FIGURE 3. Map of the Cordiner Peaks area, showing the runway site survey location north of Rosser Ridge.

Figure 4. Aerial view of Rosser Ridge and location of surveyed site (dashed line).

FIGURE 5. View (towards east) of ice surface at Rosser Ridge site

FIGURE 6. View (towards west) of ice surface at Rosser Ridge site

FIGURE 7. Crevasses near east end of surveyed site at Rosser Ridge

FIGURE 8. Closeup of crevasse near Rosser Ridge

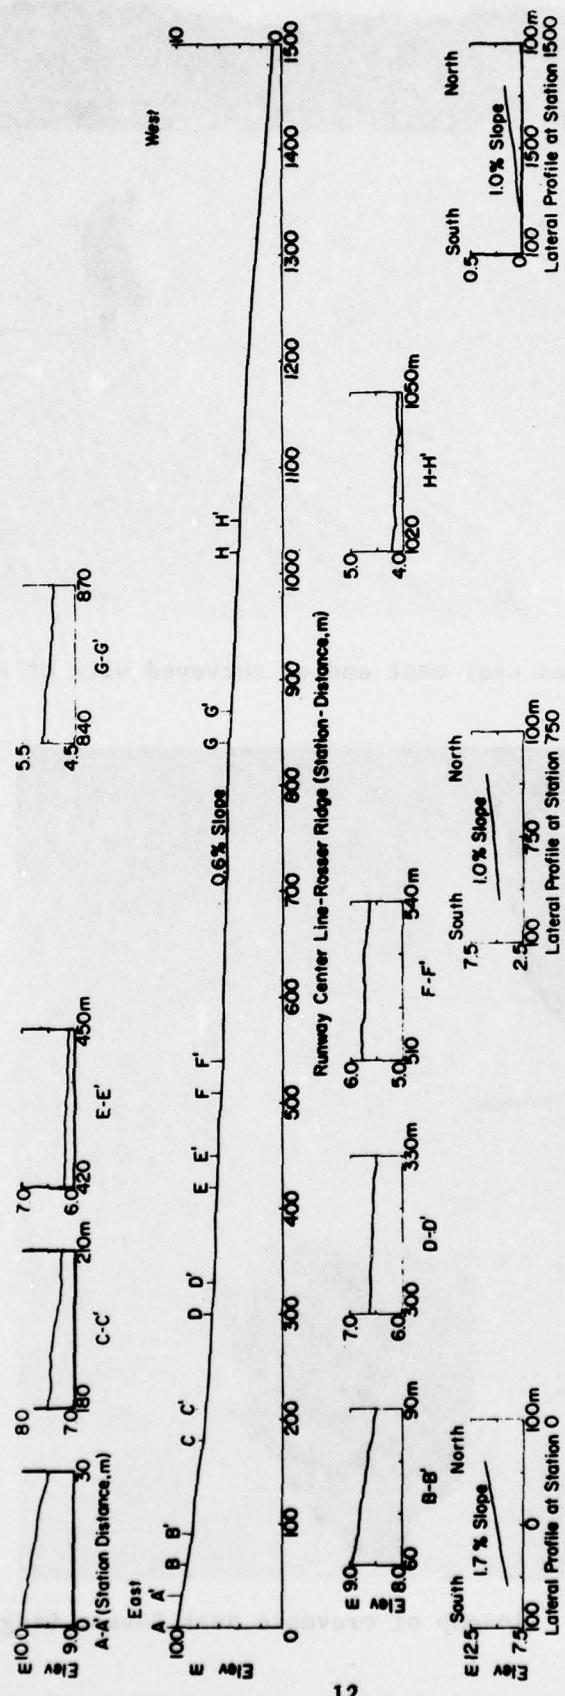
Terrain grade: (Fig. 9) approximately + 0.6% toward E (longitudinal), approx. + 1.0% toward N (lateral) for most of area, 1.7% at the east end; ice surface relief profile is shown in eight 30-m-long sections in Figure 9.

FIGURE 9. Ice surface profile at Rosser Ridge site

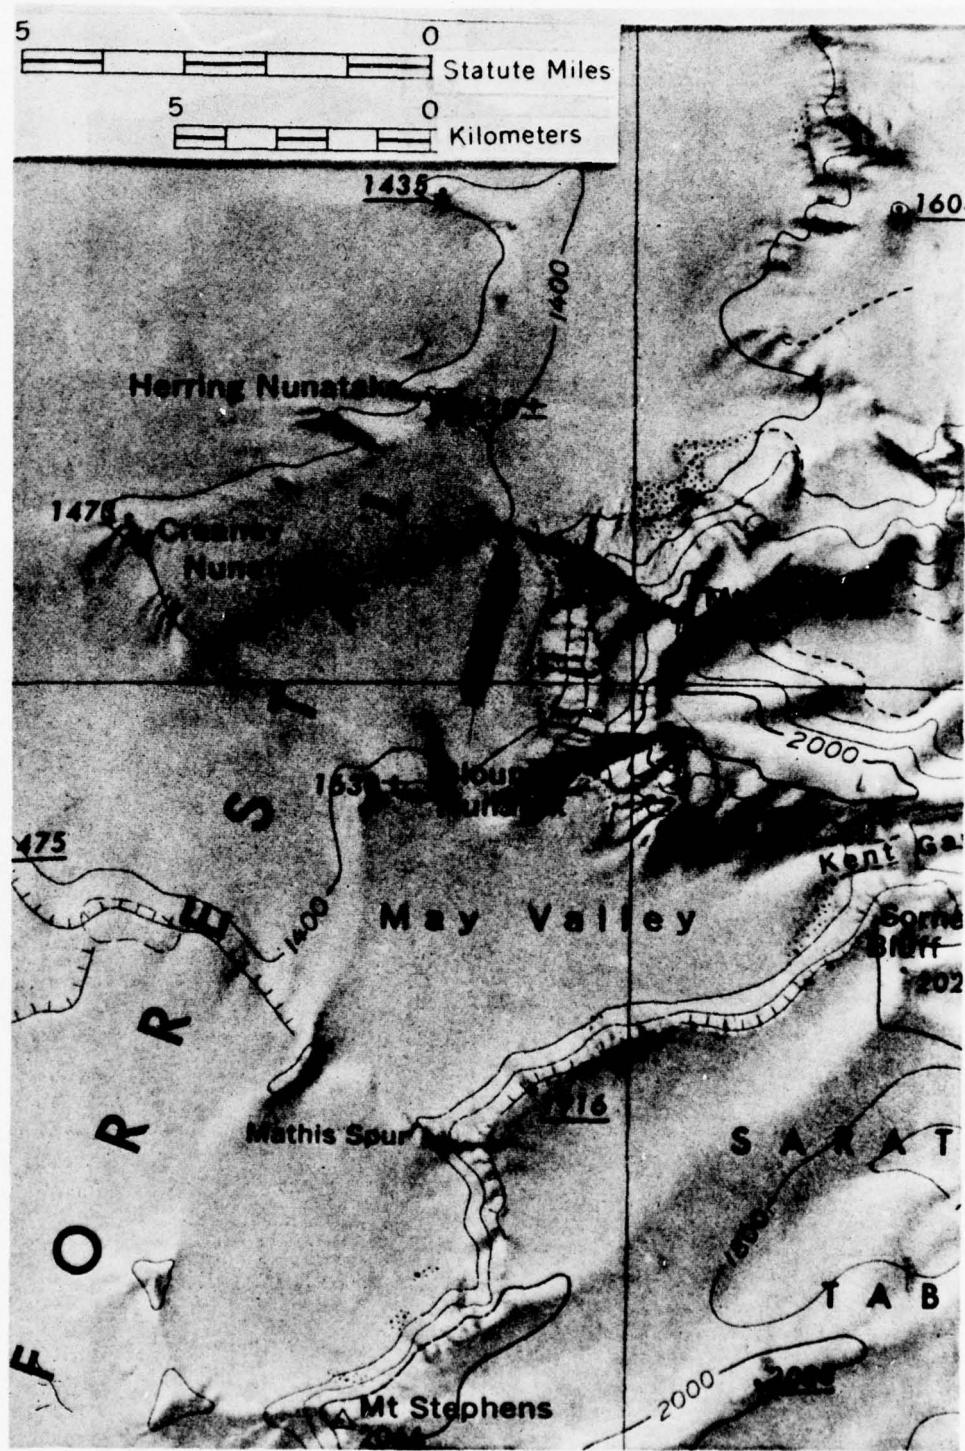
Figure 12. Map of the Mt. Lechner area, showing the runway site survey location (solid line) north of Blount Nunatak.

The runway at Mt. Lechner could be oriented in a SW to NE direction, further away from Mt. Lechner, into the predominant wind, thus decreasing the crosswind problem, the approach being from SW with the Blount Nunatak on the right (refer to Fig. 12). This runway location, however, would present very extensive snow removal problems.

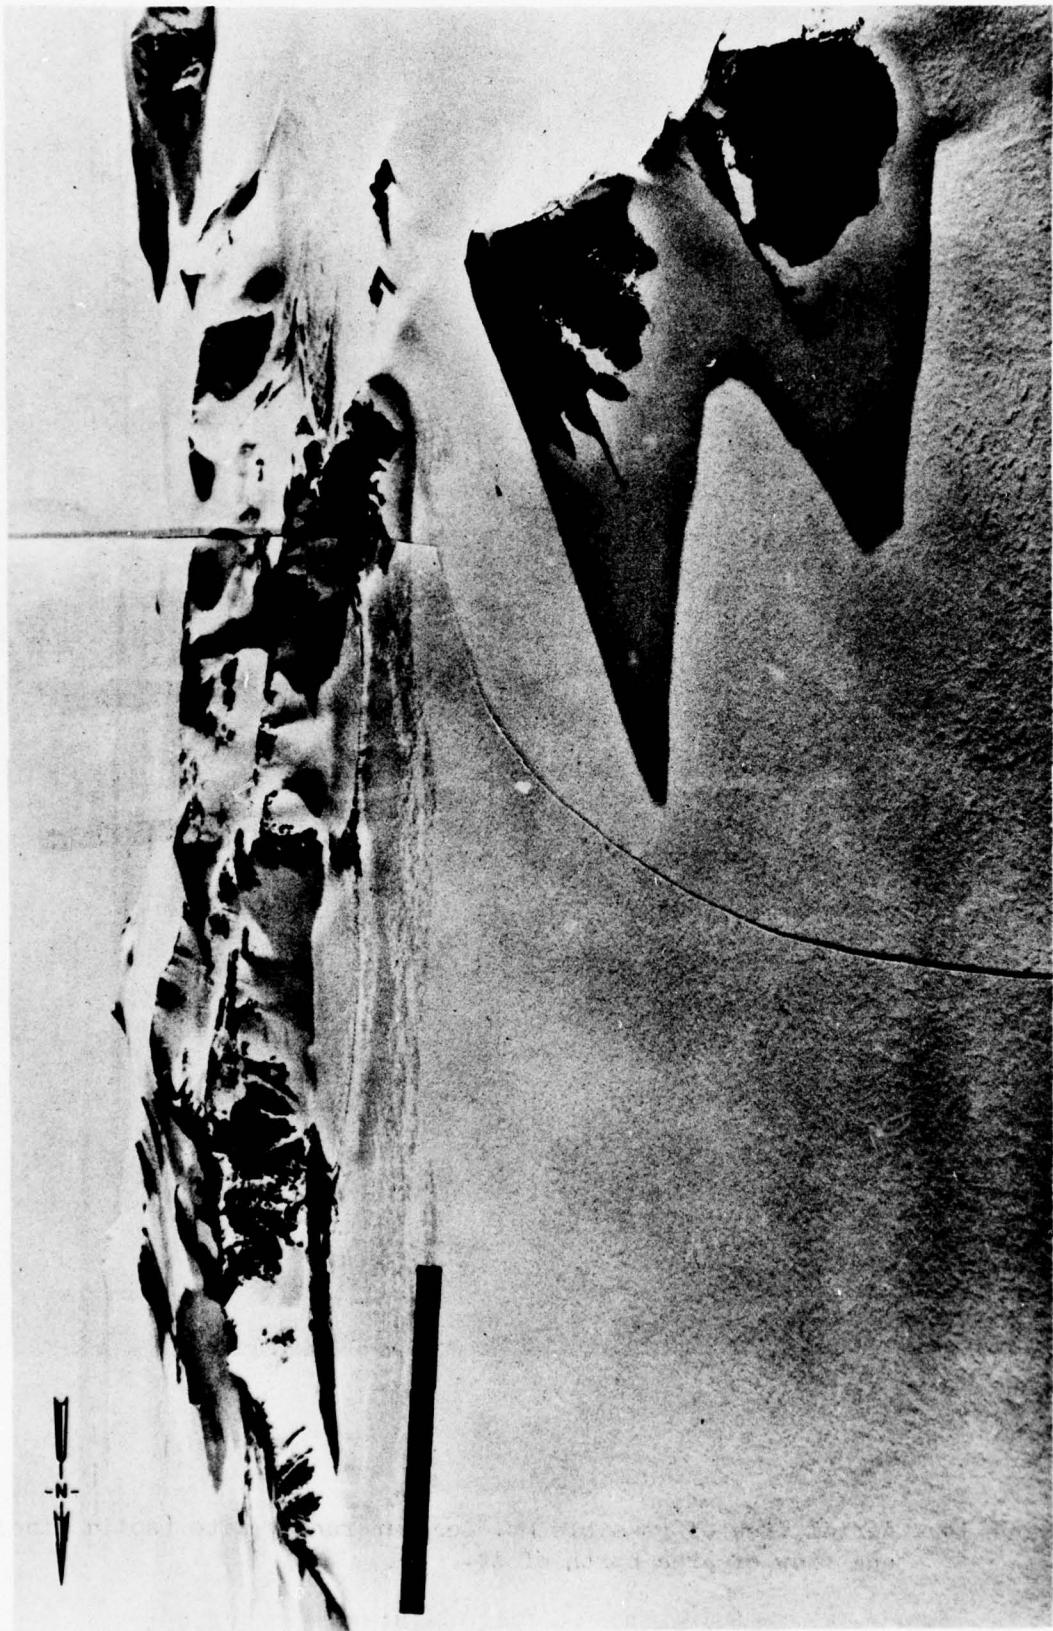
FIGURE 13. Aerial view of Mt. Lechner site and area (Blount Nunatak at lower right) south of it

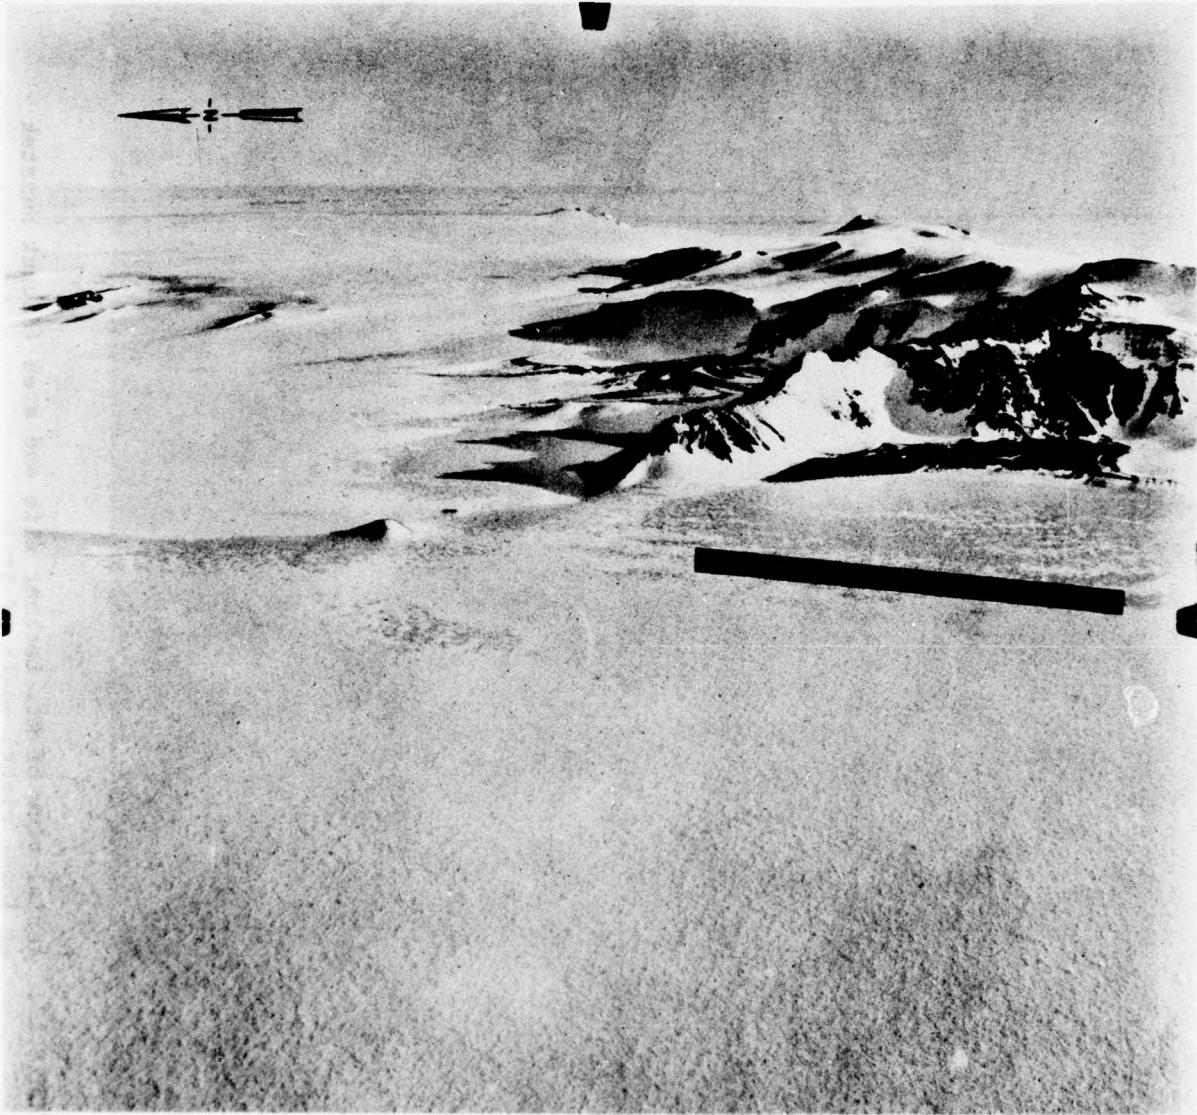
Figure 14. Aerial view of possible Mt. Lechner runway site (solid line) and view of area north of it.

Lechner, is east and parallel to the runway, the crest of the ridge being approx. 2 km from the runway; there are nearby obstacles at both ends of the runway site; the most prominent feature is Blount Nunatak at the southwest corner (Fig. 14).

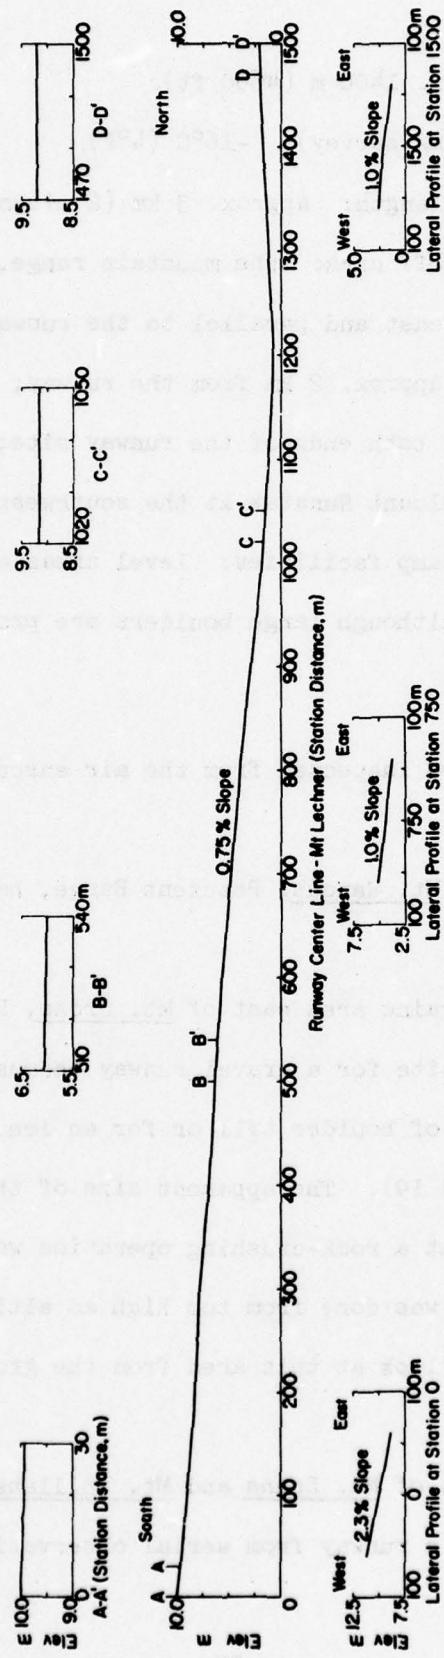
Terrain grade: (Fig. 15) approx. + 0.75% toward S, (longitudinal),
approx. + 1.0% toward W (lateral) for most of area, 2.3% at
the north end; ice surface relief profile is shown in four
30-m long sections in Figure 15.

FIGURE 15. Ice surface profile at Mt. Lechner site

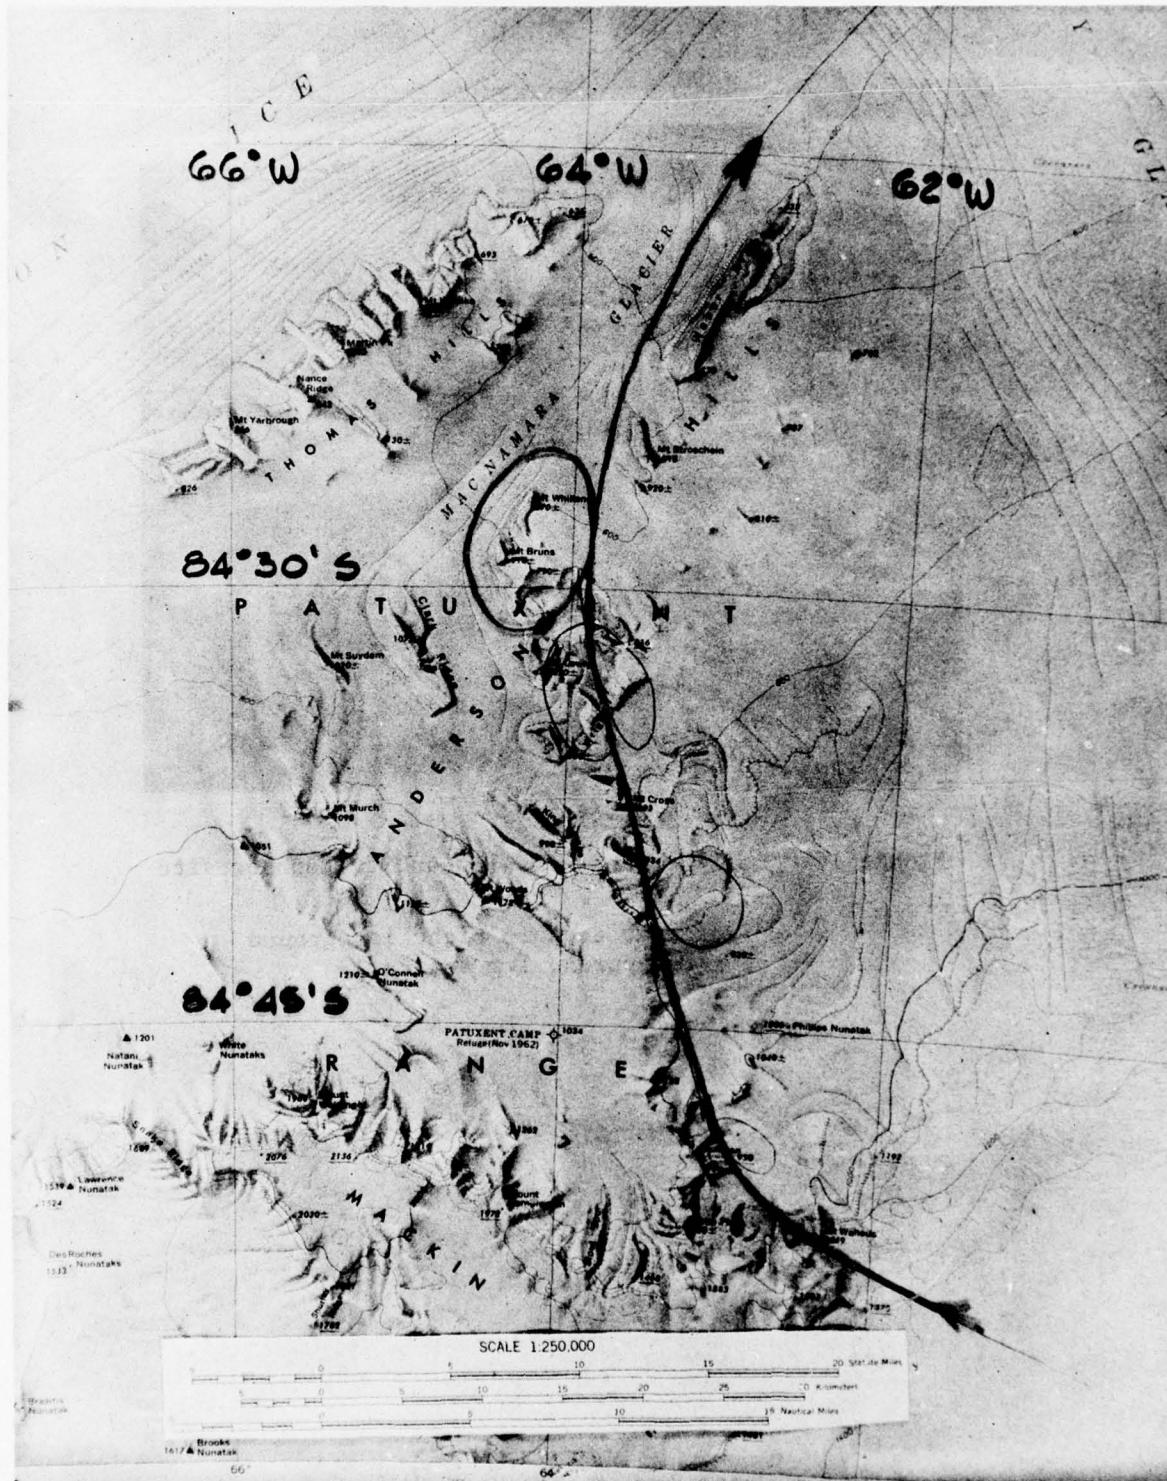
FIGURE 17. Map of potential sites inspected from air.

Several sites were inspected from the air enroute to the put-in area (Fig. 17).

The site near Mt. Hawkes, Neptune Range, was found to be totally unsuitable for runway purposes because of steep and undulating grade and approach restrictions.

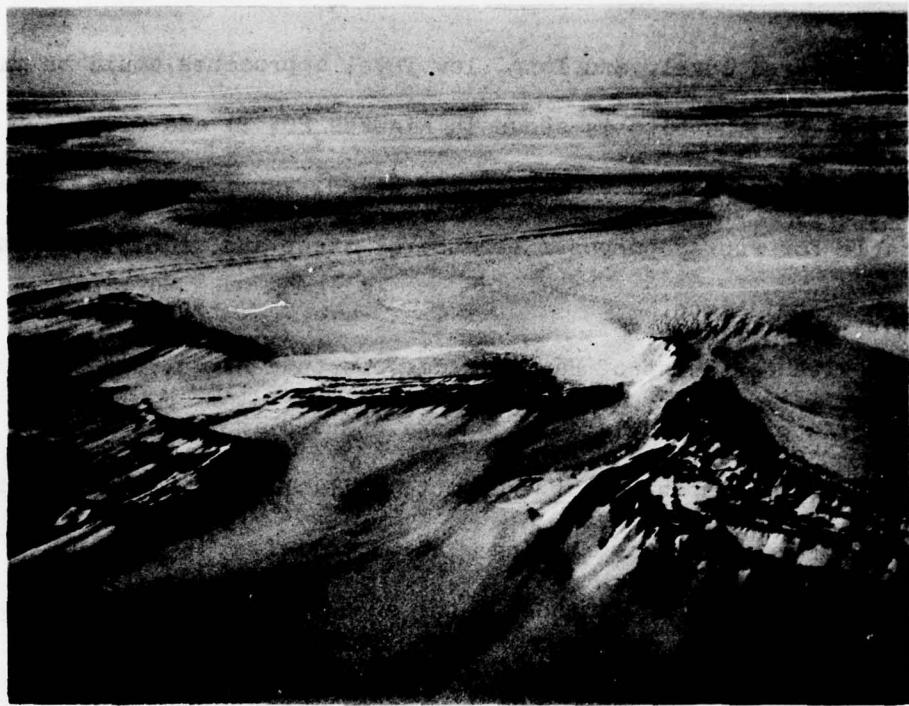
The extensive moraine area east of Mt. Cross, Patuxent Range, was viewed as a possible site for a gravel runway because of the presence of a considerable amount of boulder till or for an ice runway next to the moraines (Figs. 18 and 19). The apparent size of the boulder till material indicates that a rock-crushing operation would be necessary. The aerial inspection was done from too high an altitude for proper evaluation. A closer look at this area from the ground is considered warranted.

FIGURE 18. Aerial view of area east of Mt. Cross

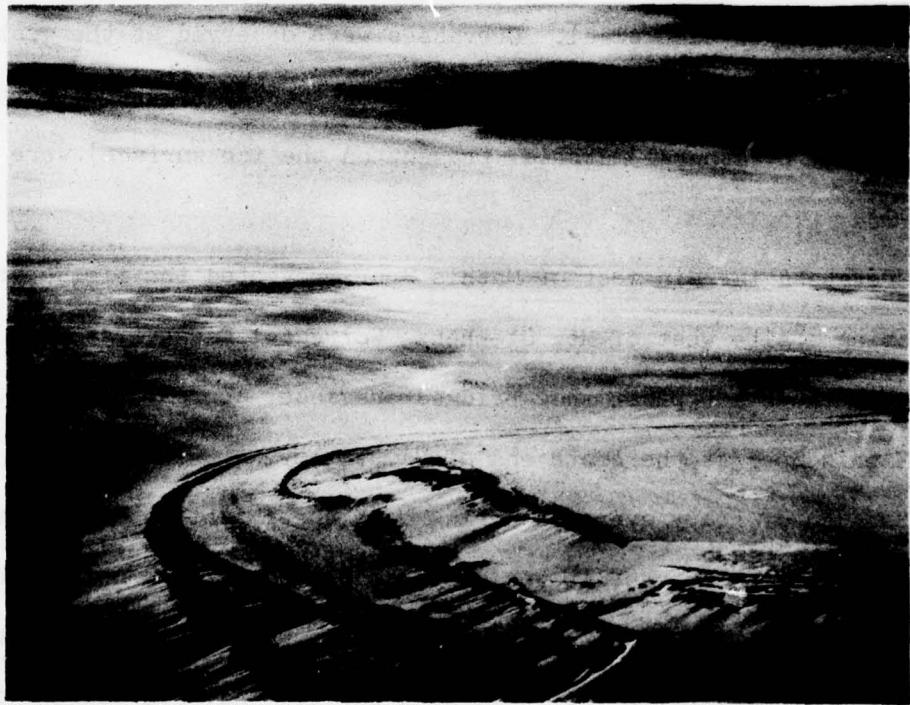
FIGURE 19. Aerial view of moraine east of Mt. Cross

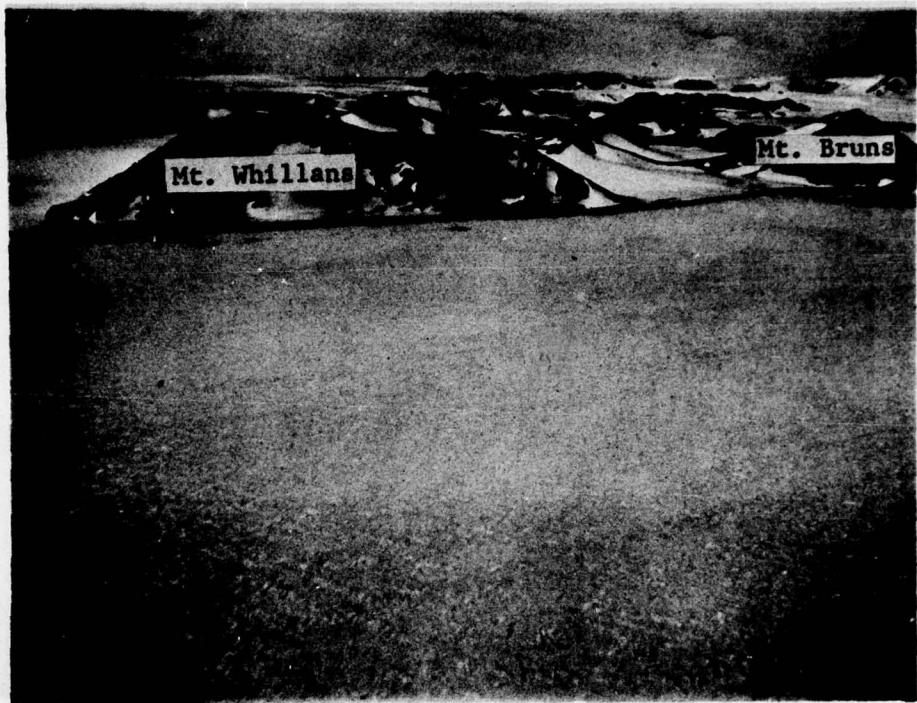
The ice area west of Mt. Bruns and Mt. Whillans, Patuxent Range, appeared suitable for a runway from aerial observation. The blue ice

terrain appeared level, and long, low level approaches could be made into the area. The site is shown in Figures 20, 21 and 22.

FIGURE 20. Aerial view of area west of Mt. Whillans and Mt. Bruns

Aerial inspection disclosed at least one other area which may be suitable as a runway site. The blue ice area west of Mt. Bruns and Mt. Whillans, Patuxent Range, appeared level, sufficiently long and without approach and takeoff constraints. A ground inspection and survey of this area is recommended.

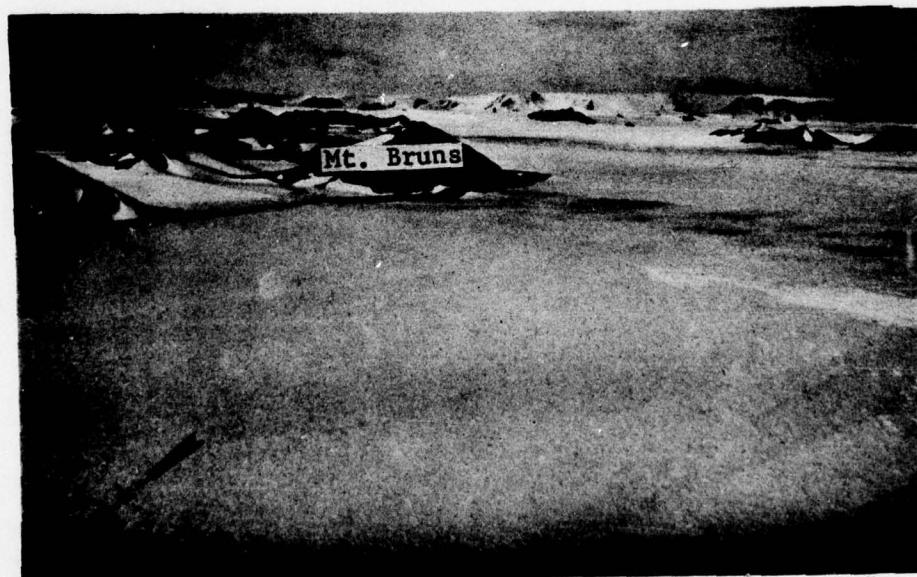
FIGURE 21. Aerial view of area northwest of Mt. Bruns

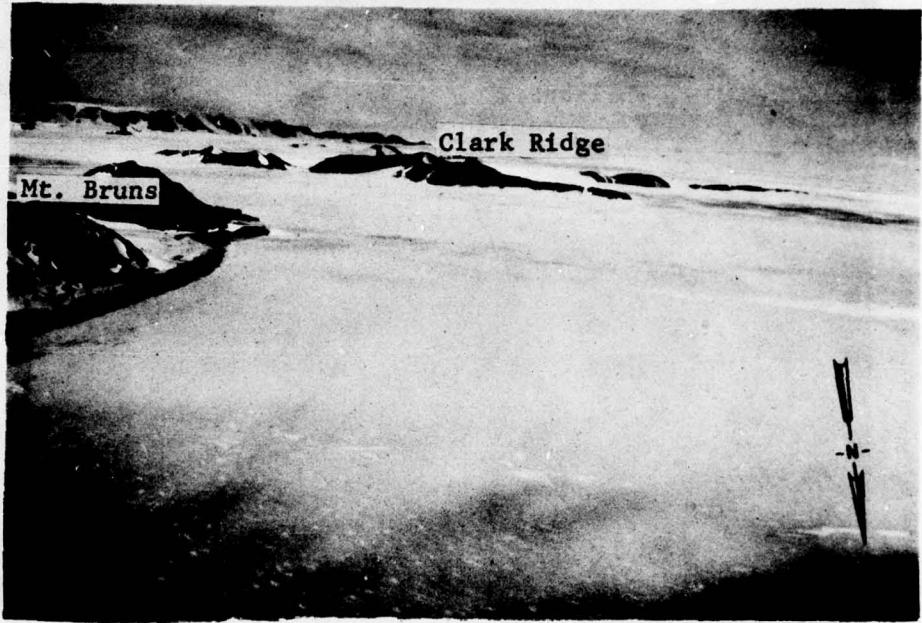
FIGURE 22. Aerial view of area west of Mt. Bruns

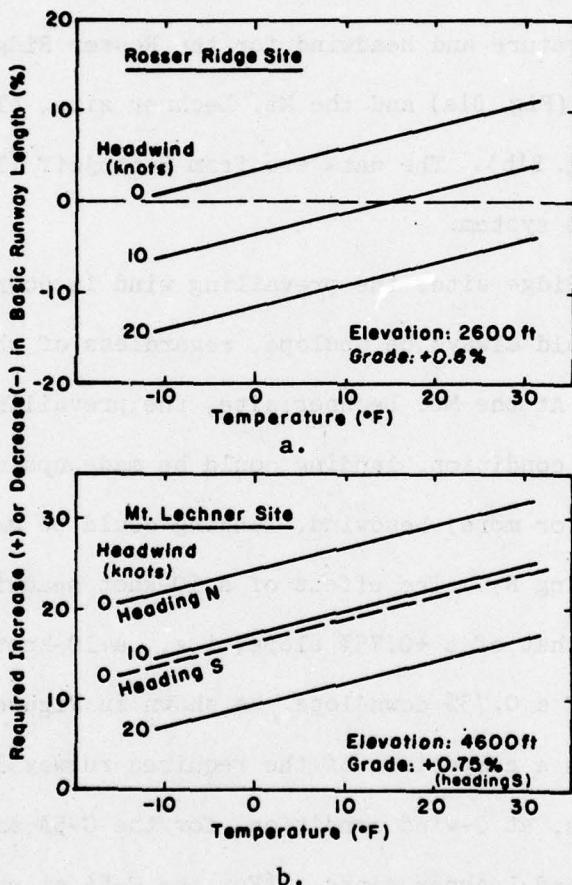
Figure B1. Effect of temperature and wind on required runway length at Rosser Ridge and Mt. Lechner.

At the Rosser Ridge site, the prevailing wind is downslope; consequently, landing would always be upslope, regardless of whether headwind is present or not. At the Mt. Lechner site, the prevailing wind is upslope; at no-wind condition, landing could be made upslope (heading S), while at a 10-knot (or more) headwind, landing could be made downslope into the wind (heading N). The effect of a 10-knot headwind is approximately the same as that of a +0.75% slope, i.e., a 10-knot headwind would cancel the effect of a 0.75% downslope, as shown in Figure Blb.

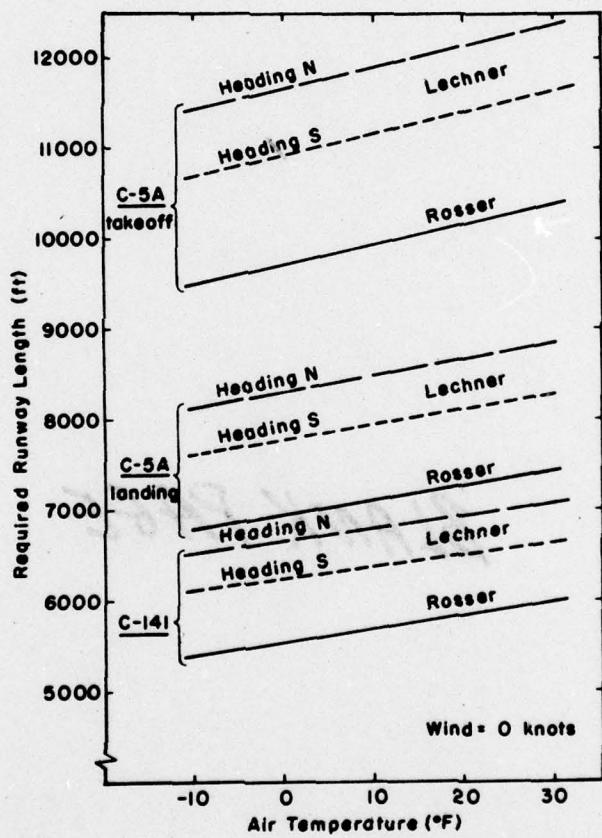
Figure B2. Effect of temperature on required runway length for C-5A and C-141 aircraft at Rosser Ridge and Mt. Lechner.

Figure B2 shows a comparison of the required runway length at various temperatures, at 0-wind condition, for the C-5A and C-141 aircraft at both the Rosser and Lechner sites. (For the C-5A at gross load, the landing distance requirement is 29% less than that for takeoff.)

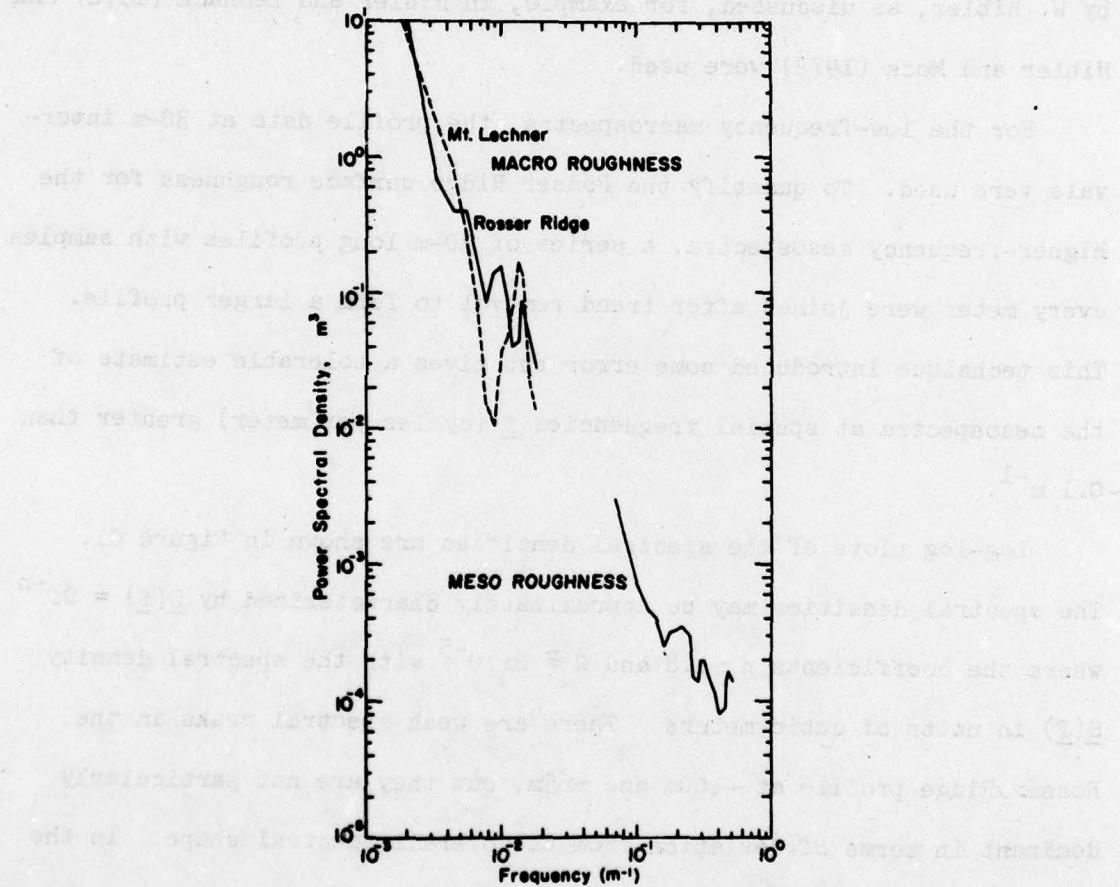
In terms of typical roughness of runways as reported by Bekker (1969), these surfaces are rougher, with spectral densities $\sim 10^2$ to 10^3 greater

Fig. C1. Power spectral density of ice surfaces surveyed.

than those given for a smooth runway, and are somewhat representative of a "rough road" spectral density. This however, is not a particularly valid criterion, since field runways are often considerably rougher than commercial runways. In terms of the Rosser Ridge root-mean-square (rms) mesoroughness, it was found that, at wavelengths less than ~ 10 m, the rms roughness was less than 1 cm.
